Re: June 2015 Monthly Progress Report  
Administrative Settlement Agreement and Order on Consent for Removal Action  
U.S. EPA Region 10 Docket No. CERCLA 10-2009-0255  
Gasco Sediments Site within the Portland Harbor Superfund Site

# Visual Observations Log Form

**Monitoring Period:** Monthly (Year 9) — June 2015

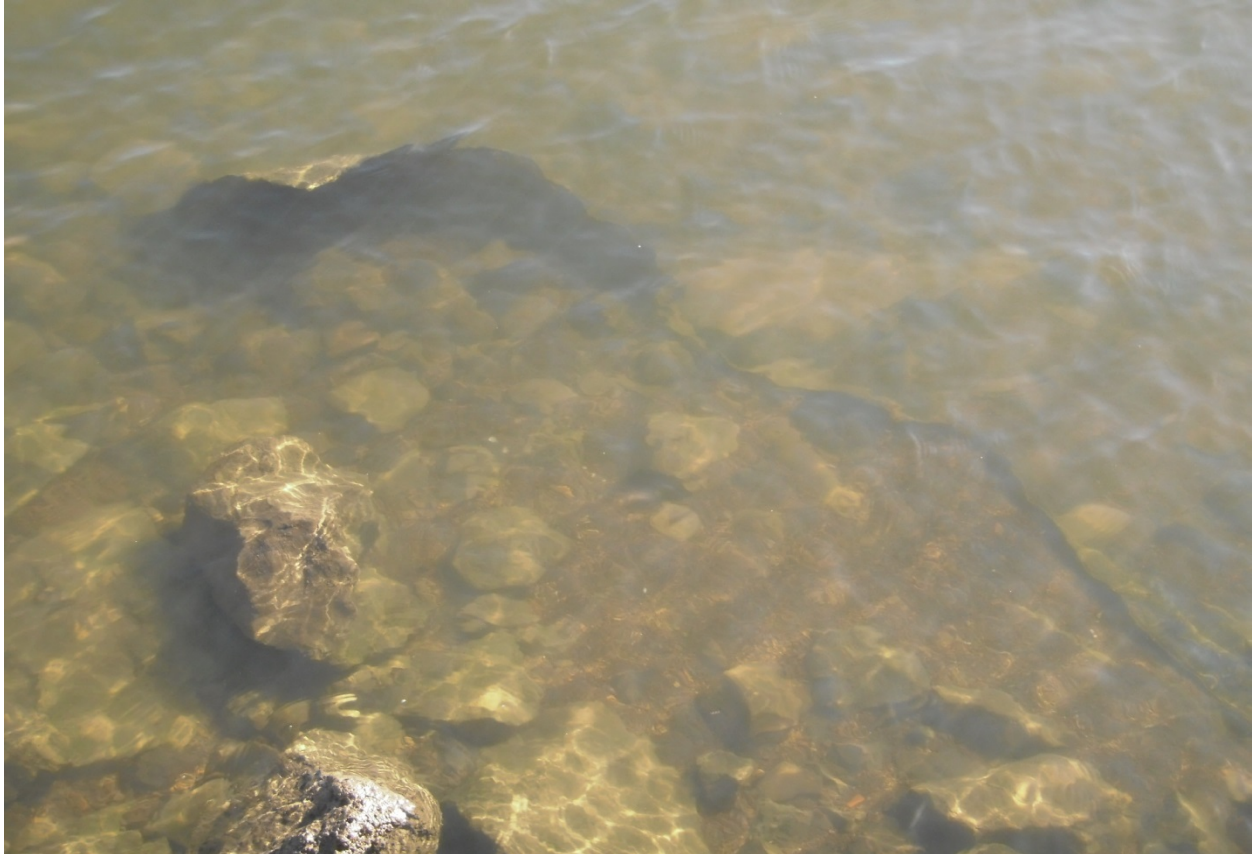
**Observations of Erosion/Deposition:** No erosion / deposition was observed along the shoreline. All previously noted organoclay mat material segments are submerged. The 5 foot section near the lateral midpoint of the cap area is the only segment visible and is in 1 to 2 feet of water (Photo 1).

Photo 1 — *Visible section of organo-clay mat near the lateral midpoint of cap area (6/17/15):*

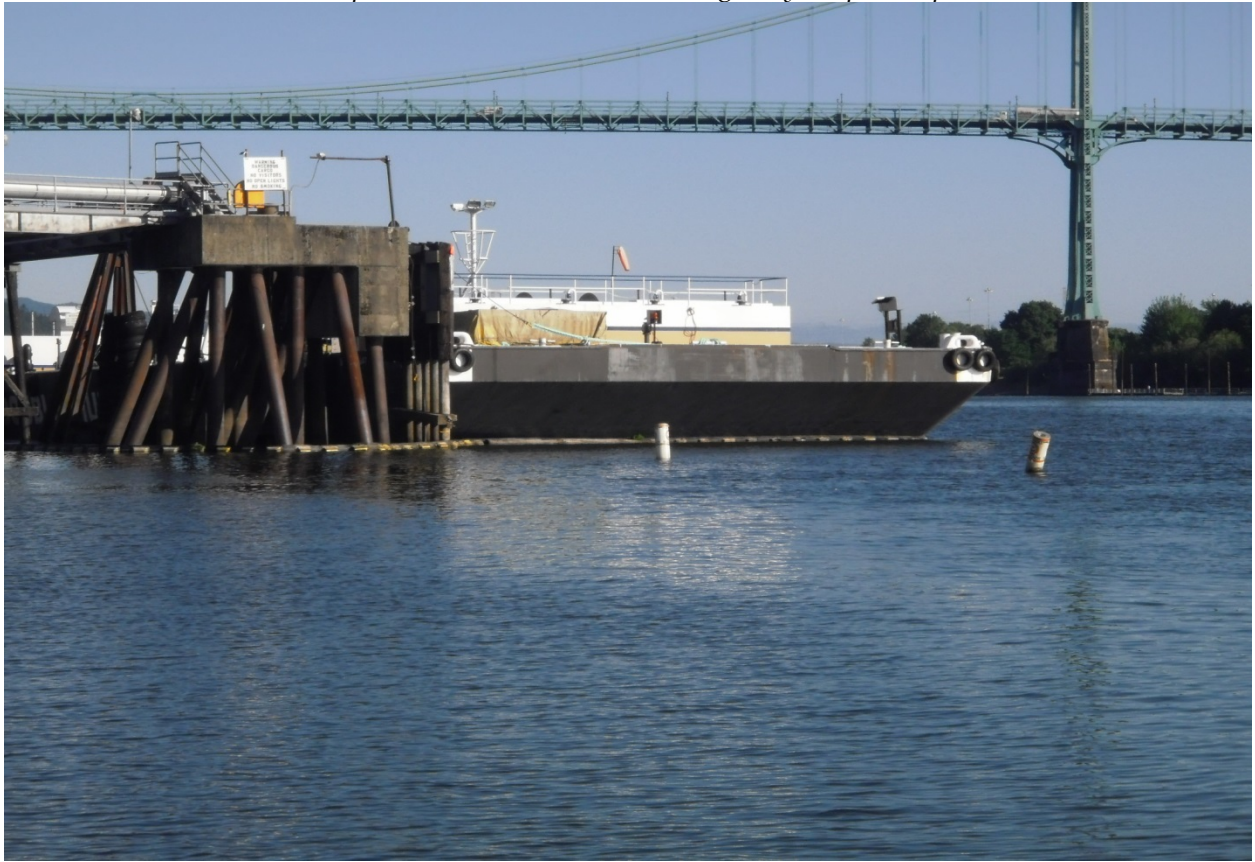
**Observations of Long-term Controls (i.e., oil booms, organo-clay mat, etc.)** During the observation, the Fuel and Marine Marketing (FAMM) containment boom was in place across the cap area, between the upriver corner of the ship dock and the wooden dolphin (near the upriver extent of the site and near the Siltronic Corporation outfall). Two buoys that identify the cap area to mariners are in place as installed. The position of the FAMM oil boom, warning buoys, and a general overview of the site shoreline is shown in Photo 2.

Photo 2 — *FAMM oil boom placement and mariner warning buoys at pilot cap area. (6/17/15):*

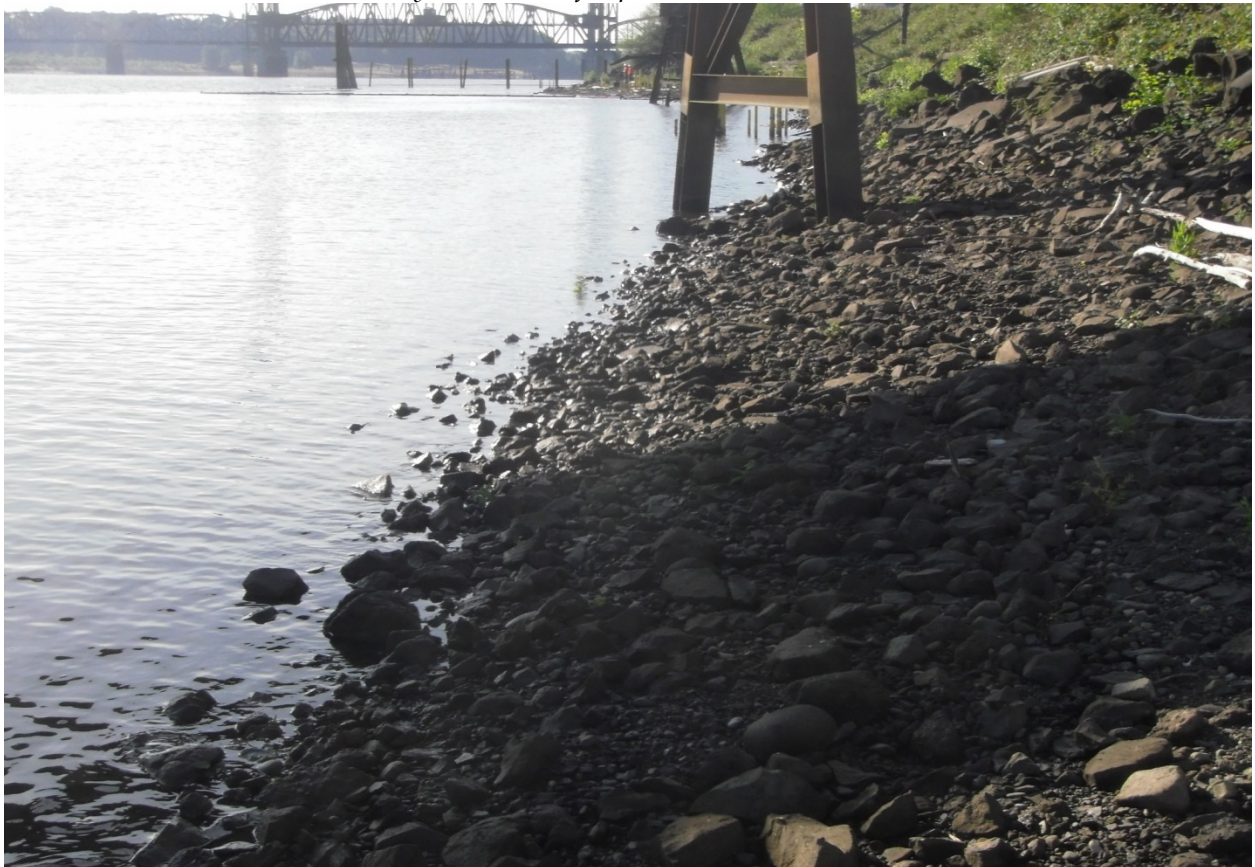
No sheen is evident in or around the cap area. Photo 3 shows the water surface and shoreline immediately downriver of the sediment cap.

Photo 3 — *Conditions immediately downriver of cap area (6/17/15):*
